Massport raises two cranes

A West Coast consultant figured a way to raise the height of two East Coast low-profile container cranes without taking them out of service—a feat that he says has not been done before.

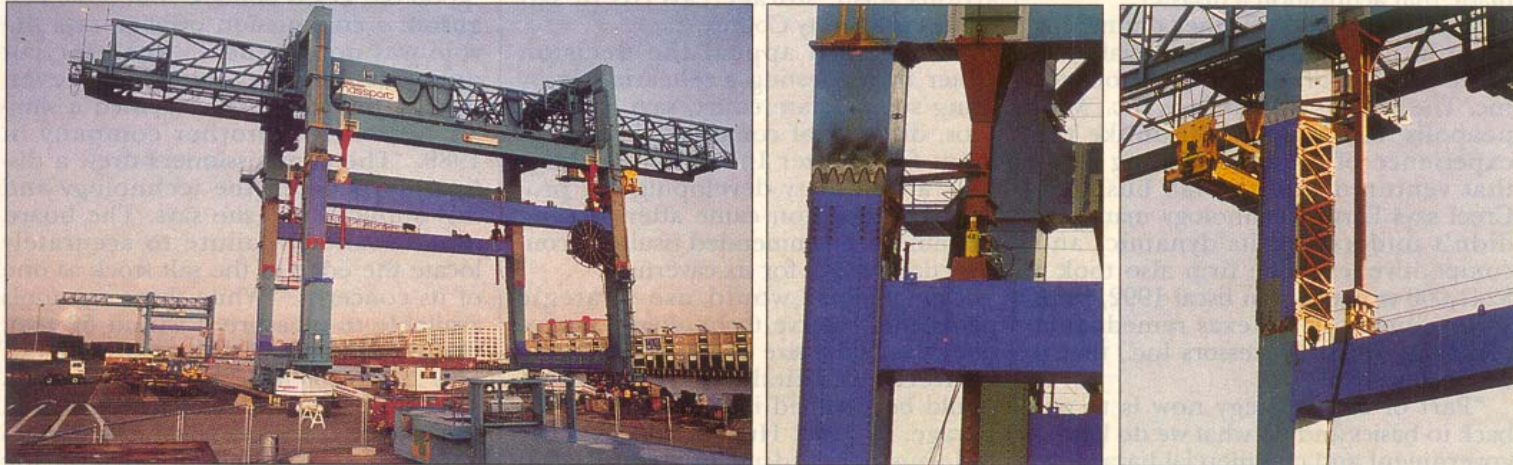
New portal beams, painted blue, were installed, and jacks were based on them (center photo). Holes in telescoping sleeves welded to crane legs above the cut enabled it to be temporarily bolted to leg if crane was needed. Temporary cross bracing, installed as jacking proceeded, was replaced with plates.

Casper designed a technique to install telescoping sleeves on two faces of the crane legs, cutting the legs and jacking them in increments that allowed the rigging contractor to put in a series of temporary braces. The telescoping sleeves enabled crane legs to be secured so Massport could operate the crane.

A few inches above the cut in a crane leg, Dorel welded the tops of 24-ft-long, 1-in.-thick steel plates to opposite sides of the box column leg. The whole lengths of the plates were shop drilled with four rows of holes at 6-in. centers. Below the cut, riggers drilled 40 holes in the leg to match the plate's pattern. This enabled Dorel to bolt the plate to the leg if it needed to stop work.

John Snow, Dorel's project manager, says four jacks raised each estimated 840-ton crane in about 18 hours. Jacking paused while riggers inserted cross bracing in the faces of the legs perpendicular to the telescoping sleeves.

When the jacks raised the legs 20 ft, the crew welded the bottom of the sleeves to the legs and replaced the cross bracing with steel plates. ■
